6 PHASE I INSPECTION REPORT
NATIONAL DAM SAFETY PROGRAM,
Mill Pond Dam (Inventory Number NY 368),
Lake Champlain Basin, Essex County,
New York.
Phase I Inspection
Report

PHASE I INSPECTION REPORT
NATIONAL DAM SAFETY PROGRAM
MILL POND DAM
I.D. NO. N.Y. 368
LAKE CHAMPLAIN RIVER BASIN
ESSEX COUNTY, NEW YORK

Name of Dam: Mill Pond Dam (I.D. No. NY 368)
State Located: New York
County Located: Essex
Watershed: Lake Champlain Basin
Date of Inspection: April 16, 1980

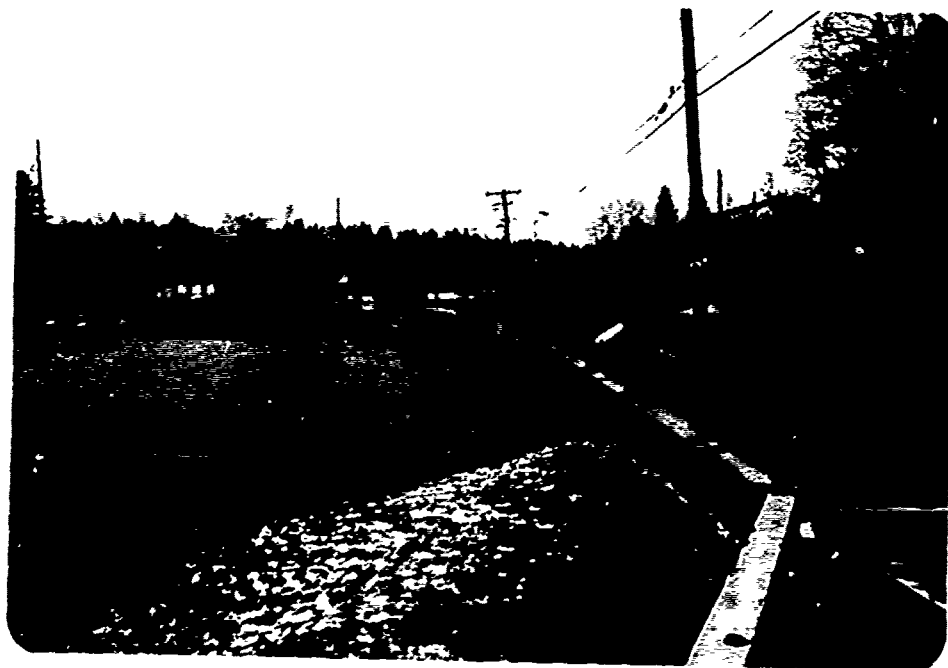
The concrete walls which extend from each end of the structure were in satisfactory condition. The wall at the southern end of the dam was constructed in 1978 and was in good condition. The wall which extends from the northern end of the dam consists of about 2.5 feet of new concrete on top of an existing wall. This entire wall extends for approximately 100 feet to the north and is in satisfactory condition. The wall terminates at this point but the top is several feet above the existing ground surface. As a result, the water could flow around the end of this wall before it would overtop the dam.

Concrete Wall which Extends from South Abutment

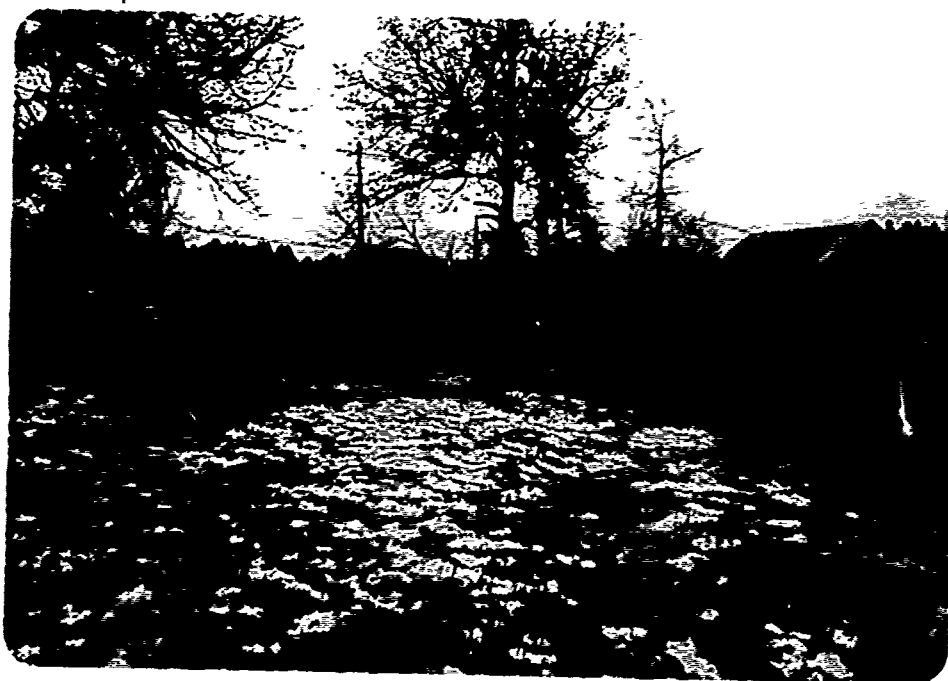
Because the ground surface beyond the end of the wall at the northern end of the dam is below the level of the top of the dam, water would flow around the end of the wall during high water conditions. Further investigation of this condition is required.

Concrete Wall which Extends from North Abutment

1. Refill any cribs which are not completely filled with stone.
2. Repair the displaced timbers on the downstream face of the dam.
3. Repair the valve on the penstock so it will operate properly.
4. Make modifications necessary to prevent flood waters from flowing around the northern end of the dam.
5. Repair the spalling and deteriorated concrete on the wingwall which extends along the downstream channel from the north abutment.
6. Replace broken planks on the spillway section.
7. Develop an emergency action plan for notification of downstream residents.

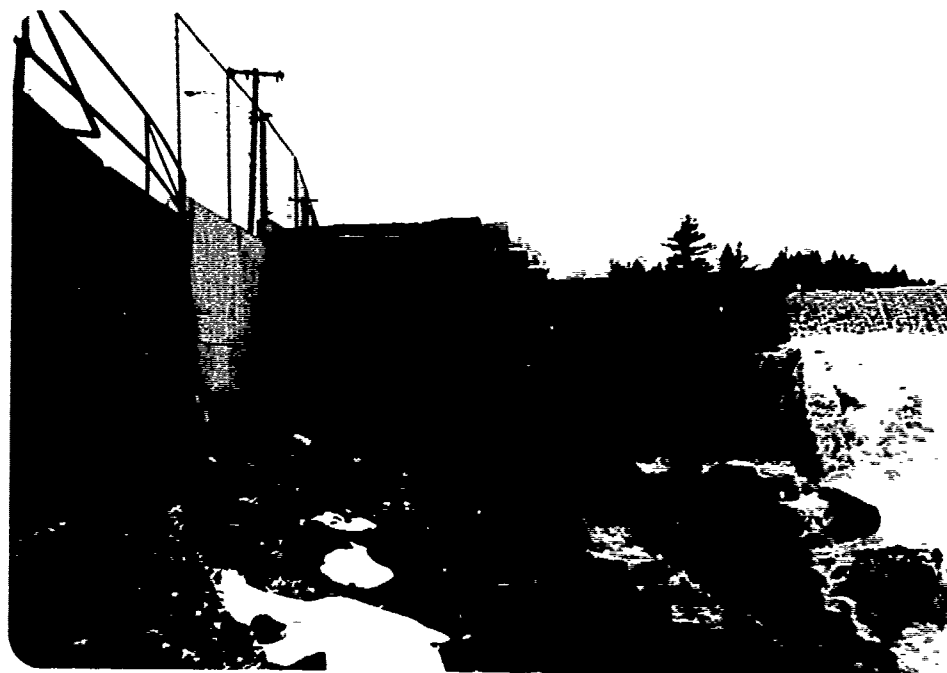
South Abutment of Dam

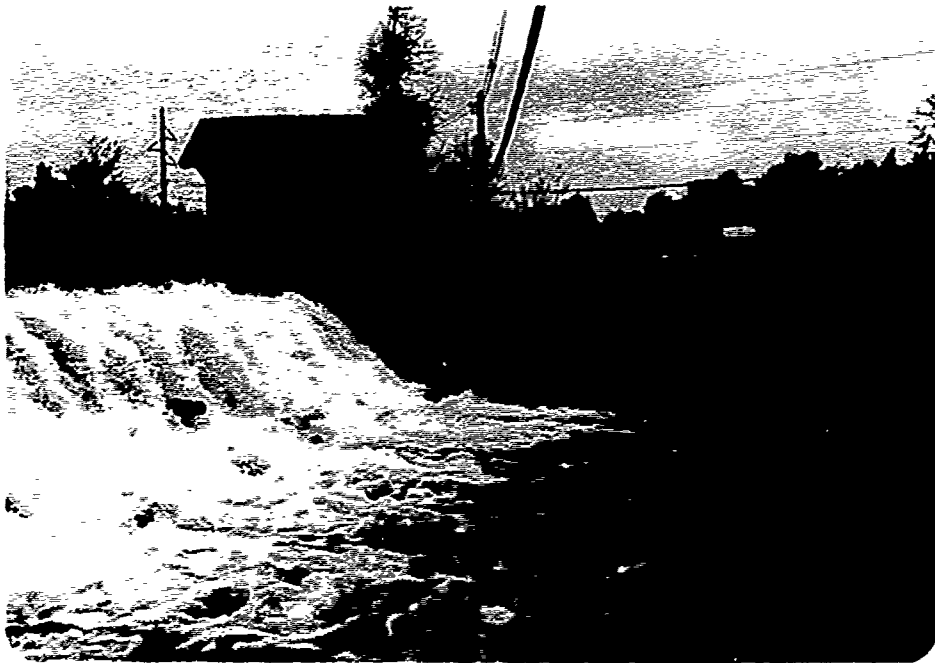
There was a wingwall which extended from the north abutment for about 20 feet along the channel. The concrete on this wall was spalling and deteriorated.

North Abutment, Gatehouse, and Deteriorated Wingwall

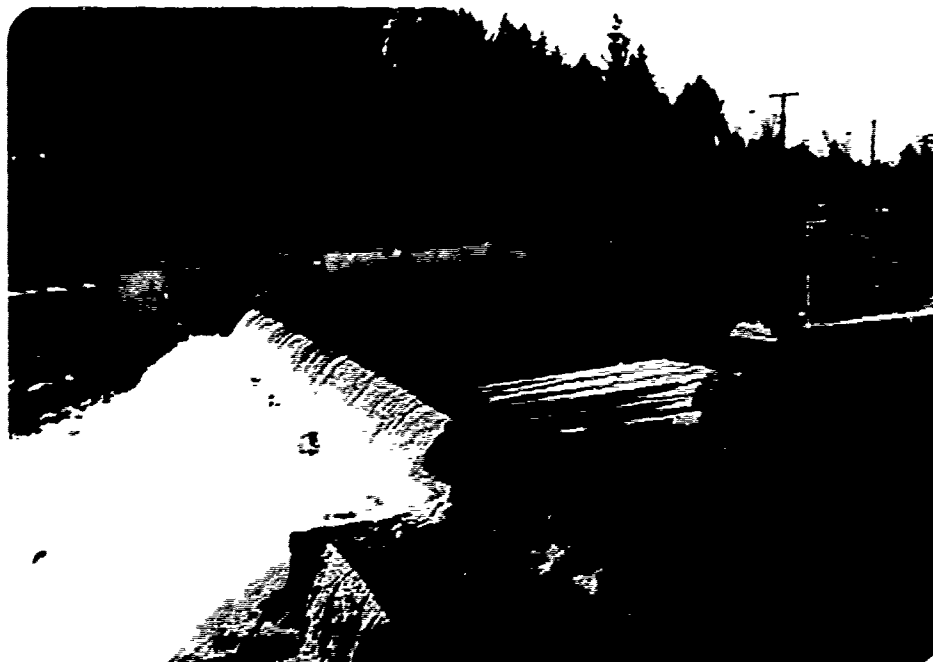
The spillway consisted of a two level channel section in the center of the dam. The tops of the cribs across the entire length of the dam were covered with hemlock planks. In the spillway section, water flowed across the planks and plunged onto the bottom level of cribs, whose tops had been left uncovered. With the exception of the backfilling problems, displaced logs, and broken planks previously mentioned, the spillway was in satisfactory condition.

Stepped Spillway Channel

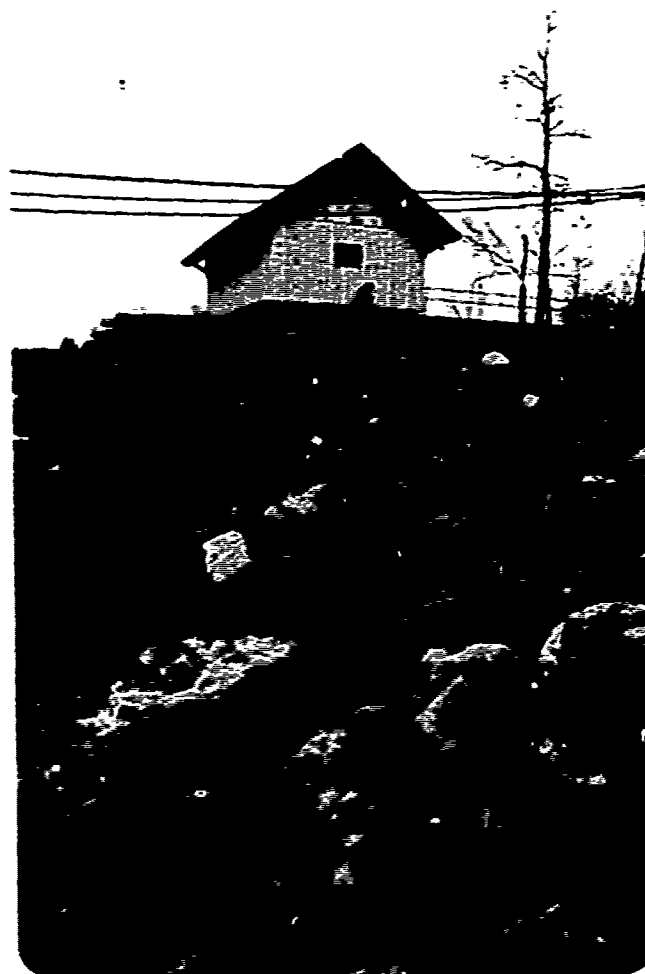
The gatehouse was in satisfactory condition. It was being reconstructed and might be converted into a museum in the future.

Gatehouse and 42 inch Outlet to Reservoir Drain Conduit

Present Condition (Describe): REPORTED THAT IT IS NOT
POSSIBLE TO FULLY CLOSE THE GATE

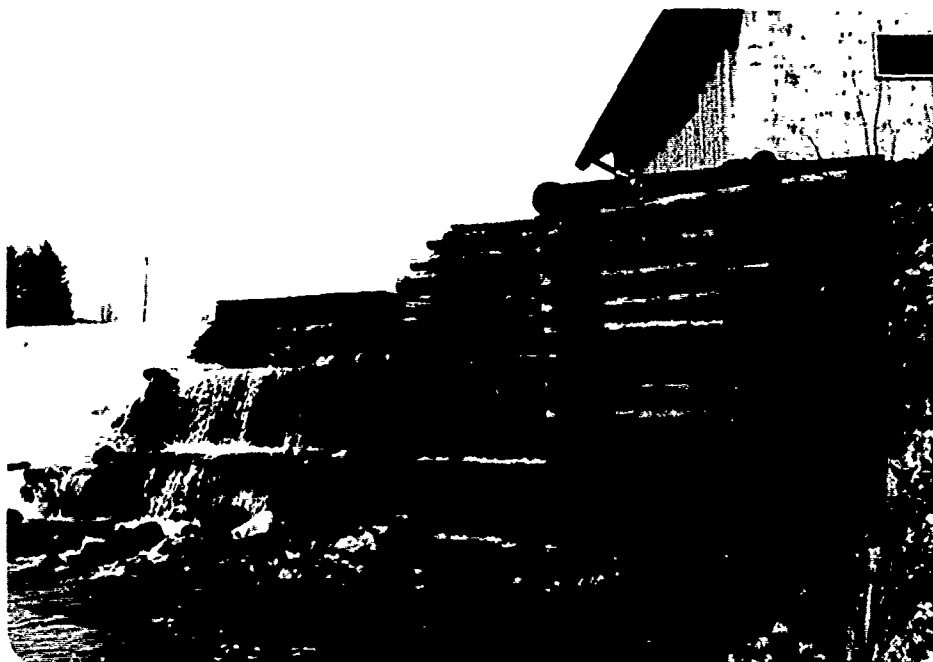
Water Flowing Through Dam and into Lower Cribs

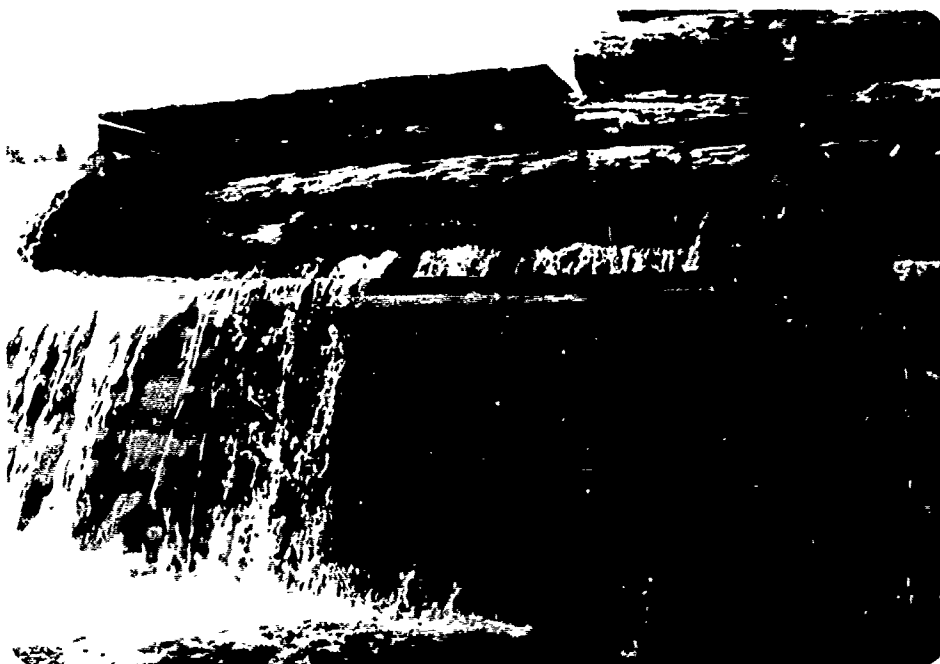
There were several timbers on the downstream face which had been displaced. One timber had come out of the crib and was at the base of the dam. Other timbers had displaced into the crib. There were also several broken planks on the second level of the timber cribs in the spillway.

Water Flowing Through Dam
Note Displaced Timber on Lower Crib
